# Aviation Investigation Preliminary Report

<b>Location:</b>	Owenton, KY	<b>Accident Number:</b>	ERA25FA005
<b>Date &amp; Time:</b>	October 7, 2024, 17:35 Local	<b>Registration:</b>	N230AE
<b>Aircraft:</b>	Bell 206L-3	<b>Injuries:</b>	3 Fatal
<b>Flight Conducted Under:</b>	Part 135: Air taxi & commuter - Non-scheduled - Air Medical (Medical emergency)

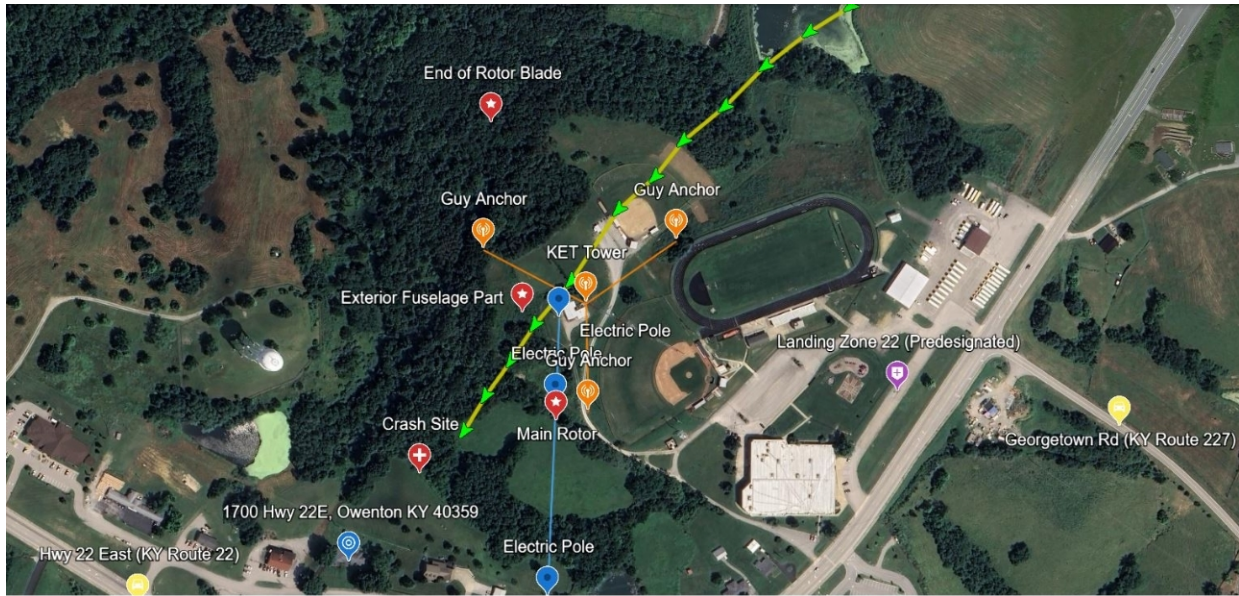
Several witnesses described that the helicopter approached from the north at "low altitude" with no unusual sounds or movements. A guyed television signal transmission tower, with a height of 601 ft above ground level (1,559 ft mean sea level) was located on the high school campus adjacent to the LZ. The witnesses saw the helicopter strike one of the guy wires supporting the tower before it descended to ground contact. Several detailed written statements described watching the helicopter strike the wire, watching the wire "move," and "pieces"; more specifically, the main rotor, separate from the helicopter, before the helicopter and the main rotor system descended separately to the ground.

ADS-B track data revealed that the helicopter approached the tower from the northeast on an approximate ground track of 210° magnetic at an altitude of about 1,300 ft msl. At the time,

the sun was 18° above the horizon on an azimuth of 246°. Figure 1 shows the area of the accident site including the helicopter's ADS-B ground track, the guyed tower, and the LZ.

Figure 1 - Aerial image with the helicopter's ground track, as well as positions of the accident site, select pieces of wreckage, the tower and guy anchors, and the LZ annotated.
